## Executive Summary

The *2015 Biennial Inspection Report* documents the inspections performed in 2015 to fulfill the Tampa Hillsborough Expressway Authority's (THEA) bond and lease purchase agreement requirements. The requirements help ensure accountability and transparency from THEA as they report this information to the general public, bond holders and other interested parties. These inspections provide the general physical condition of the roadways with recommended repairs as well as verification of capital need projects. The report includes inspection results on THEA's bridges, drainage structures, roadway pavement conditions, signage, pavement markings, other roadside paraphernalia, vegetation (turf and landscaping), buildings and lighting. The inspections were strictly visual, photographs were taken and deficiencies noted. This effort did not include testing, analyses or subsurface investigations, nor did it duplicate the efforts performed separately by the Florida Department of Transportation (FDOT) for the structural inspection of bridges and overhead signs. However, the findings of the separate FDOT inspections were reviewed and incorporated into this report for further

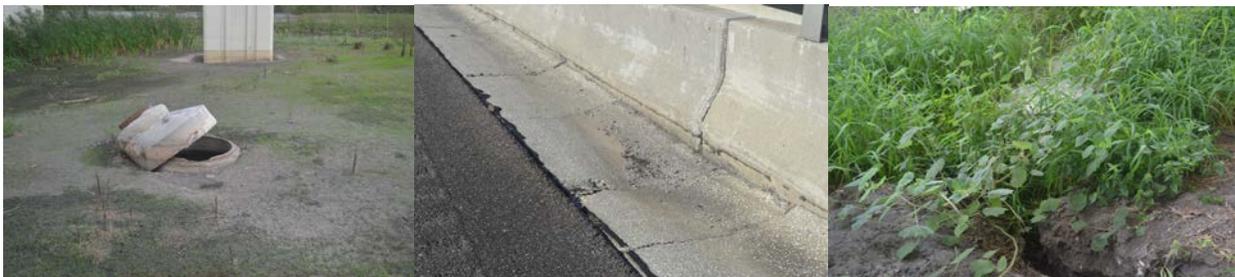
Overall, the drainage system along the Expressway is deemed functional and in fair to good condition, with the exception of a few specific issues that should be addressed. The typical drainage issues that should be addressed include: chipped / cracked / settled drainage structures, ditch pavement and shoulder gutter; broken-off manhole top; broken / missing dissipating bricks; erosion adjacent to drainage structures; excessive water build-up; and presence of overgrown vegetation, silt and debris / trash.

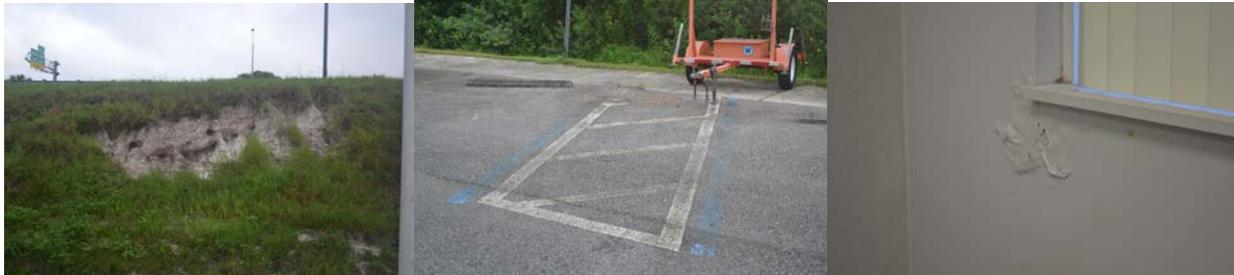
As part of the All Electronic Toll (AET) conversion, all of the toll plazas were removed and replaced with toll gantries. The only remaining building structures are the administrative buildings associated with the old West and East Main Toll Plazas. Typical issues observed pertaining to the existing condition of the administrative buildings' interior include: unclean / dirty; broken stall / toilet; excessive condensation on the air conditioner handler; leaky window causing damaged drywall; stained ceiling tiles from leaky roof; missing ceiling tiles; several light fixtures do not work; peeling wallpaper; elevator does not work, and standing water in the tunnel. The typical issues associated with the existing condition of the administrative buildings' exterior and the adjacent area include: cracked / chipped curbing, sidewalk and pedestrian curb ramps; damaged and corroded concrete columns; corner of building and door frame are damaged from impact; hole in the exterior wall; broken / cracked blue exterior wall tiles; raveling/cracking pavement in the upper parking lot; broken water fountain; light base with missing fixture and exposed wiring; graffiti on retaining wall; worn / missing striping and pavement symbols; damaged/worn signs; side slope erosion; damaged drainage structure; drainage structures, retaining wall and perimeter fence overgrown with vegetation; and presence of debris.

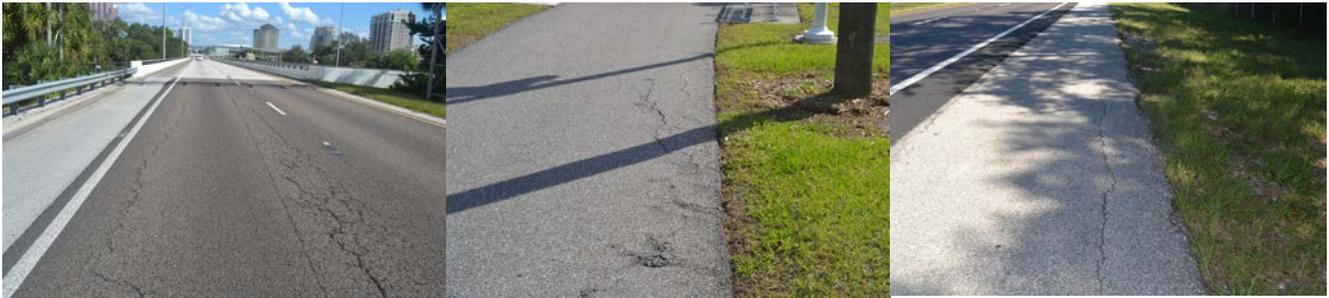
In general, the pavement and pavement markings are in good condition. The Expressway mainline pavement from Gandy Boulevard to Willow Avenue and the section of the REL from Twiggs Street to the west approach slab were milling and resurfaced in October 2014 and October 2015, respectively. The resurfacing project along the Expressway mainline did not include the paved shoulder and as a result, this pavement is in fair to good condition with both longitudinal and transverse cracking. There are isolated areas where alligator cracking and pavement raveling along the mainline and longitudinal cracking on the shoulders are prevalent. The pedestrian trails along

Meridian Avenue and the Brandon Feeder Roads had several locations where the pavement is cracking, especially adjacent to trees.

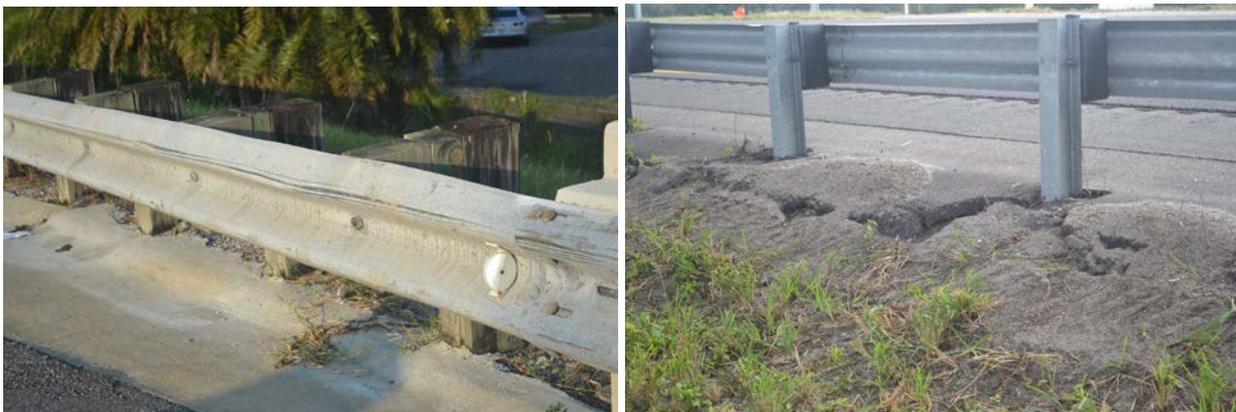
The guardrail and attenuators throughout the Expressway were inspected by Transfield, Inc. / Broad Spectrum. Refer to Appendix D for the corresponding *Guardrail Deficiency Summary Reports* and *Attenuator Deficiency Summary Report*. The following attenuator deficiencies were noted: compressed cartridges; backward cartridges; damaged racks in nose cone; loose / twisted hardware plates; debris and asphalt build-up. The guardrail deficiencies noted include: loose cable and bolts; missing locknuts, lap bolts and nails; damaged blocks (broken, split or twisted); damaged end treatment; missing reflectors; eroding and/or missing asphalt around posts; posts need to be reset; and graffiti on end reflective panel.
